SAMiflex Solution No. 4

SAMiflex chosen to handle the extremes of South West Queensland

Winter start poses problem for Warrego Highway project engineers

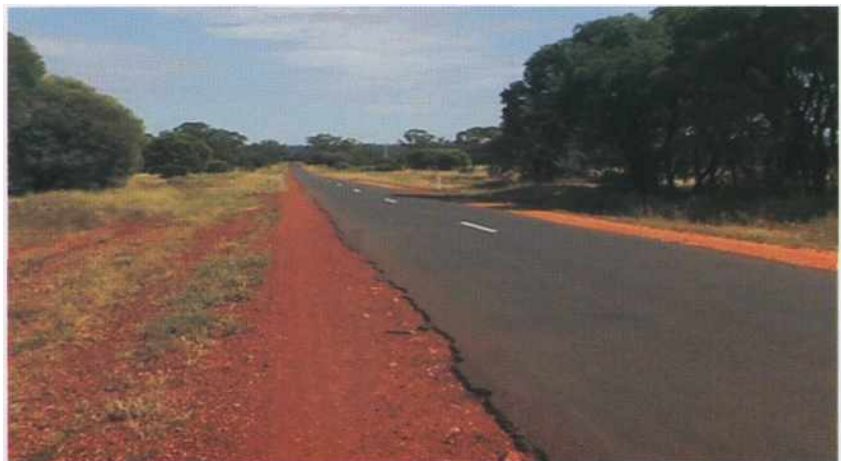
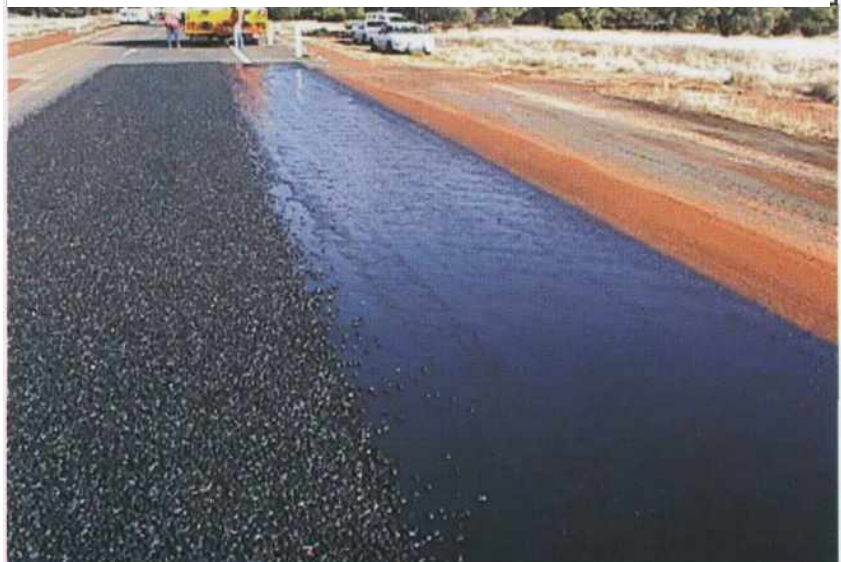
The existing seal width was 5.5m. It was cracked but still had good shape. The shoulders were weak, especially after rains, and the outside wheel paths had significant deformation, caused mostly by the heavy road train traffic and the soft shoulders.

These photos show the transformation of one section of Queensland DMR's Warrego Highway project. The top photo shows the original cracked seal showing the weak shoulders and wheel path deformation due to heavy rain and traffic. The bottom photo shows the SAMiflex E50 high residue polymer modified emulsion being applied to the full width of the pavement. The shoulders were in-situ stabilised and formation width increased to 9.0m.

The SAMiflex E50 high residue emulsion allowed the seal to stretch over existing cracks and to eliminate the risk of water damage to the joint in the future.

The Highway's wheel track deformation was shape-corrected using cold asphalt

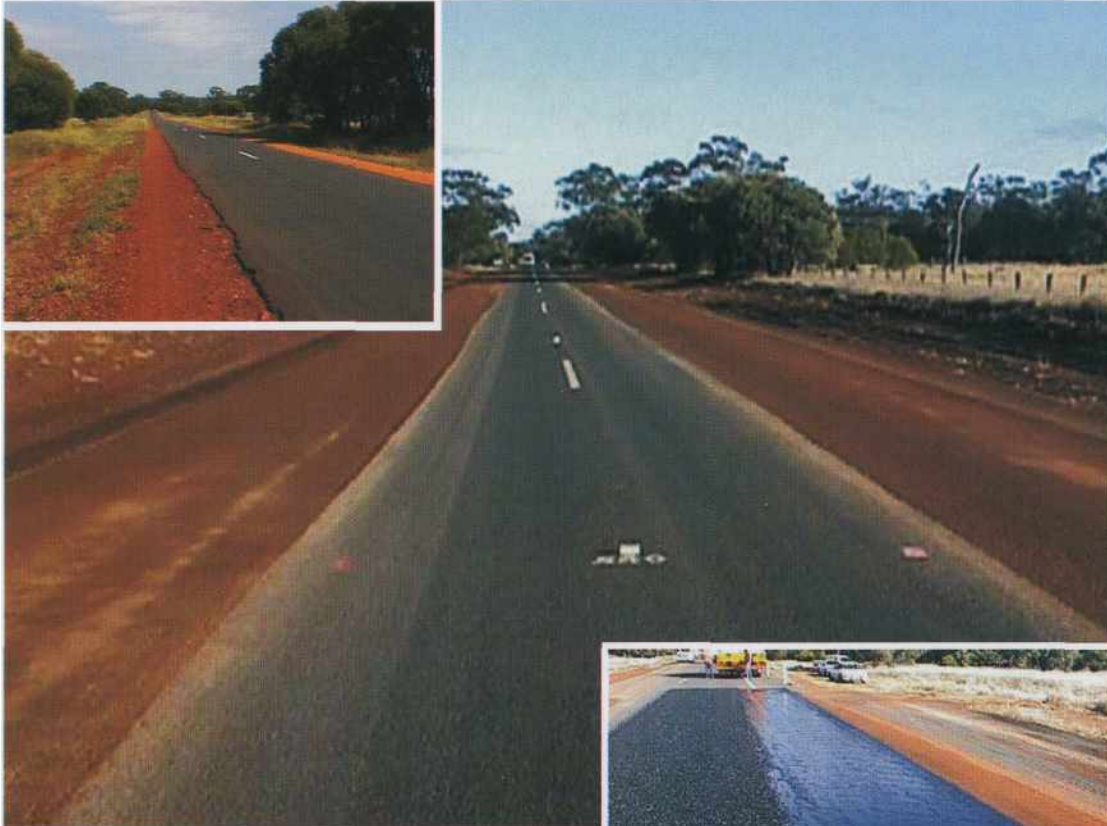
These photos show a section of Queensland DMR's Warrego Highway project in various stages of repair. The shoulders, weakened by constant wheel-path deformation and heavy rain, were in-situ stabilised and formation width was increased to 9.0m (centre photo). The SAMiflex E50 was able to be sprayed directly onto the prepared surface of the stabilised widened shoulders, eliminating the need for a primer seal.

with some areas sealed with C170 bitumen. The shoulders were in-situ stabilised and formation width increased to 9.0m.

The SAMiflex E50 was able to be sprayed directly onto the prepared surface of the stabilised widened shoulders eliminating the need for a primer seal.

2.8 - 3.0 litres per m² of

SAMiflex E50 was applied and covered with a 16mm pre-coated sealing aggregate.
