Gilsabind 'S' Queensland Transport

Gilsabind 'S' Solution No. 1

Stripped pavement gets second life thanks to Gilsabind "S"

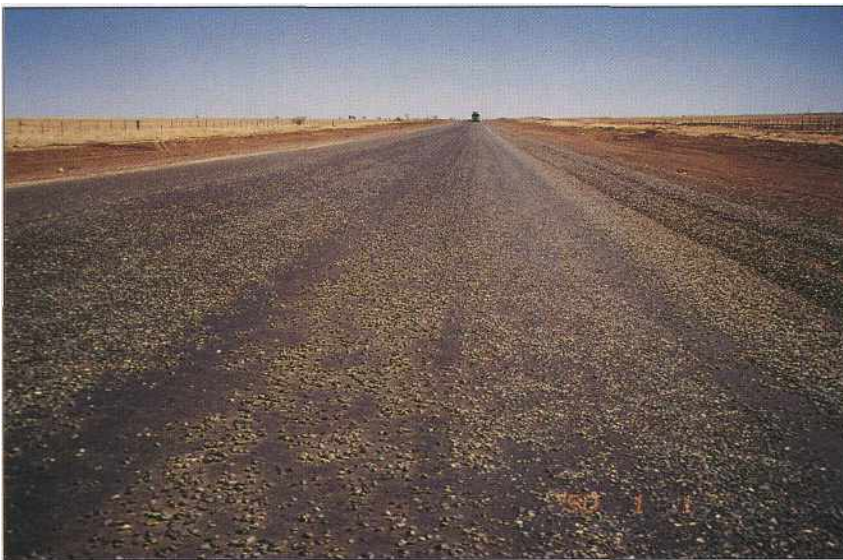
A 2 km long section of the Landsborough Highway in Central West Queensland had stripped badly and was even bare in places.

SAMI was recently called on by Queensland Transport to assist in rehabilitating a defective sprayed seal on a 2 km long section of the Landsborough Highway, near Winton in Central West Queensland, which had stripped badly.

Both lanes of the highway, which is part of the National Highway Network, were very patchy, making the pavement unsightly and lowering the skid resistance of the surface.

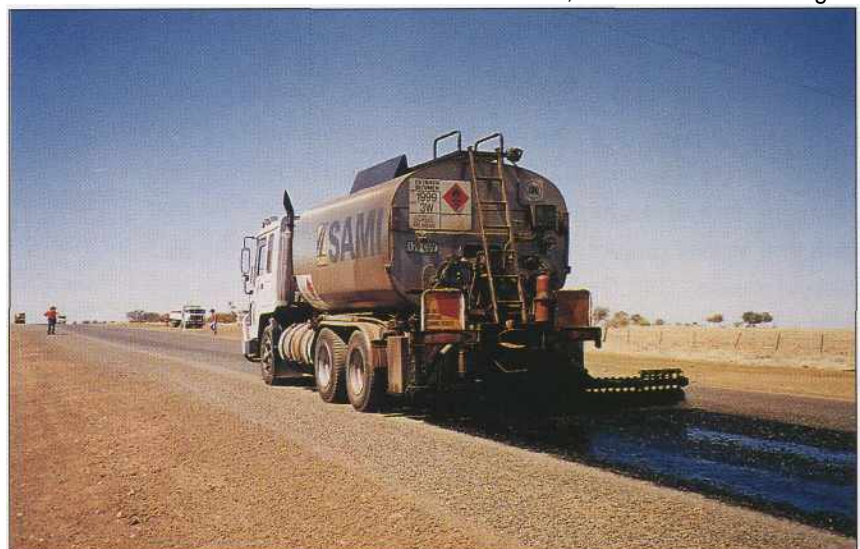
After being sprayed with Gilsabind "S", the existing polymer modified bitumen softened sufficiently to accept a new application of aggregate.

After inspecting the surface at the Landsborough Highway, SAMI recommended spraying Gilsabind "S" at a rate of 0.45 litres/m².

Gilsabind "S" penetrated the existing bitumen and softened it to a depth of about 4 mm within about 10 minutes. 10 mm pre-coated aggregate was then spread and rolled into the new bitumen compound by Queensland Transport.

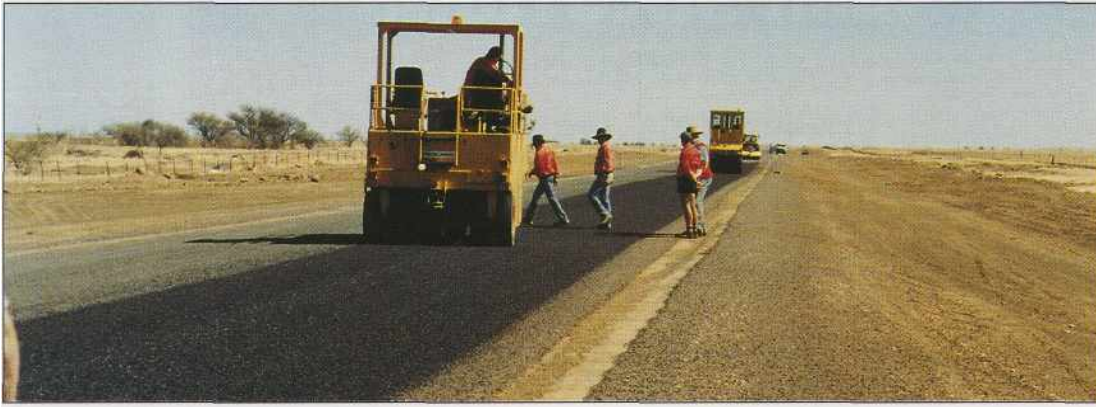
Queensland Transport's Alister Cullen said the Gilsabind "S" treatment had worked very well.
