# SAMI SOLUTIONS

## GlasGrid RTA Wagga Wagga

GlasGrid Solution No. 2

## RTA reflects on success of GlasGrid

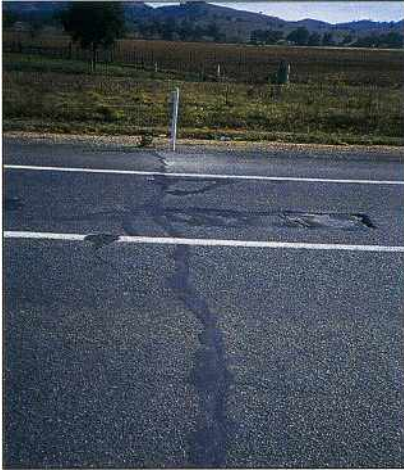
Left: The extent of cracking on the Hume Highway prior to treatment with GlasGrid and AC overlay. Above: The paving process.

This 1 km long section of asphalt pavement is only a couple of years old, but was exhibiting extensive longitudinal and transverse cracking, caused by an extremely rigid stabilised sub-base.

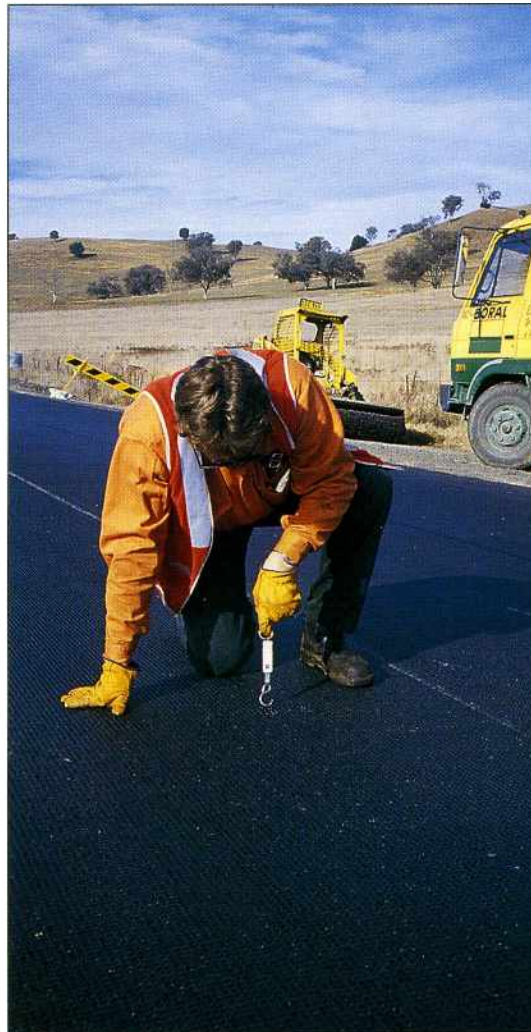
Checking that GlasGrid has properly bonded to the underlying AC layer prior to paving.

"We were also attracted to the user friendliness of GlasGrid. Because it is self-adhesive, you can put it down and start paving immediately. This helps to speed up the whole pavement rehabilitation process, which is extremely important when you are working on a major road such as the Hume Highway.

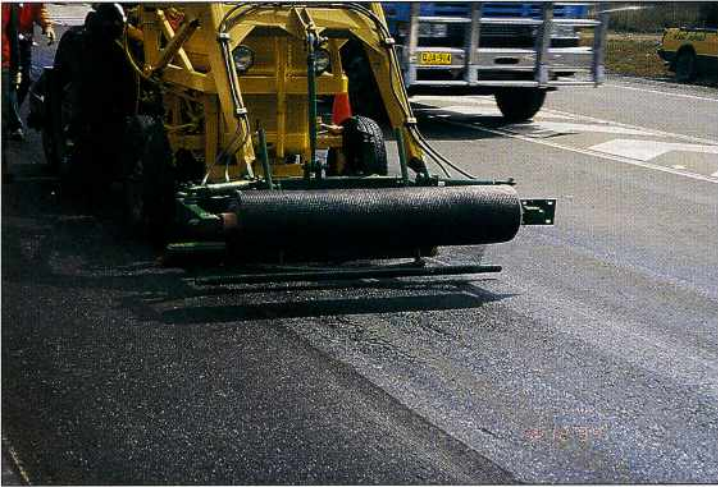
**Installation of GlasGrid is quick and easy.**

One of these was that the GlasGrid seemed to stick to the pavement surface better when placed in full sunlight. Another was that it was better to terminate the GlasGrid before it reached the edge of the pavement — the RTA was concerned that extending the GlasGrid right to the edge of the pavement may cause the top and bottom layers of asphalt to debond.

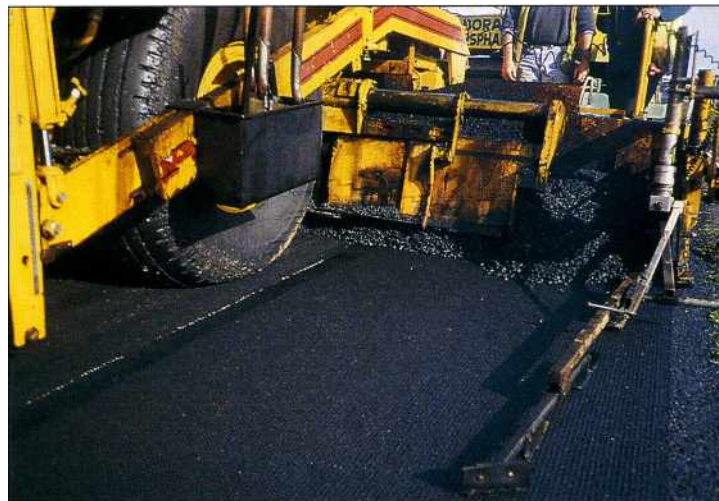
**The AC wearing course being placed over GlasGrid.**

A 70 mm thick layer of dense grade AC14 was placed over the GlasGrid, which was laid directly on top of the correction course, with the pavement being topped off with a 30 mm thick layer of open grade 10 asphalt.
