SAMI SOLUTIONS

Hot In-Place Asphalt Recycling Vic Roads/Brimbank Council

Hot In-Place Asphalt Recycling Solution No. 4

New HIPAR Technology wins rideability "road test"

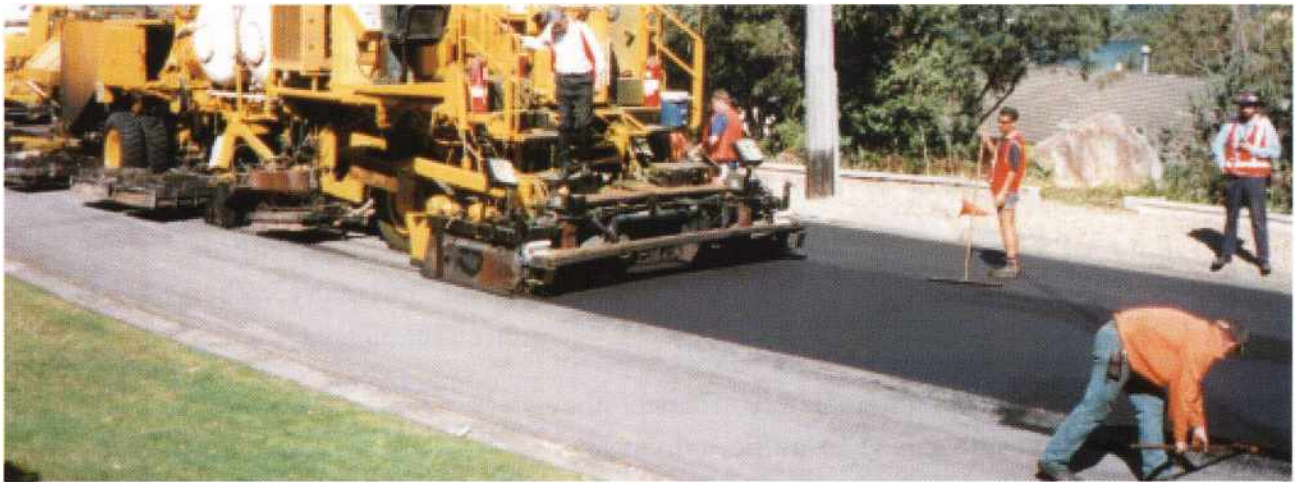
Carried out by a mobile recycling unit that heats, removes, rejuvenates, modifies and restores asphalt in a single continuous pass, the HIPAR method was praised for its time efficiency.

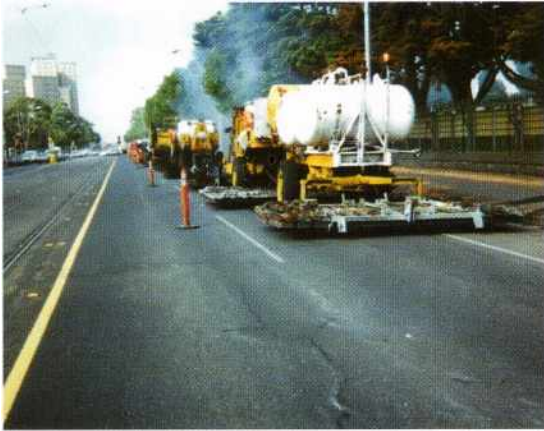
Lygon Street Melbourne, showing cracking and asphalt deformation.

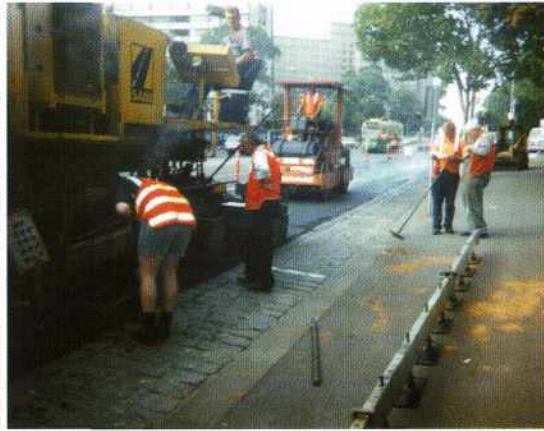
The new pavement is re-laid, neat to kerb and ready for traffic.
